REPORT NO. 3554

THE BALTIMORE AND OHIO RAILROAD COMPANY

IN RE ACCIDENT

AT WJ TOWER, NEAR WILMINGTON, DEL., ON

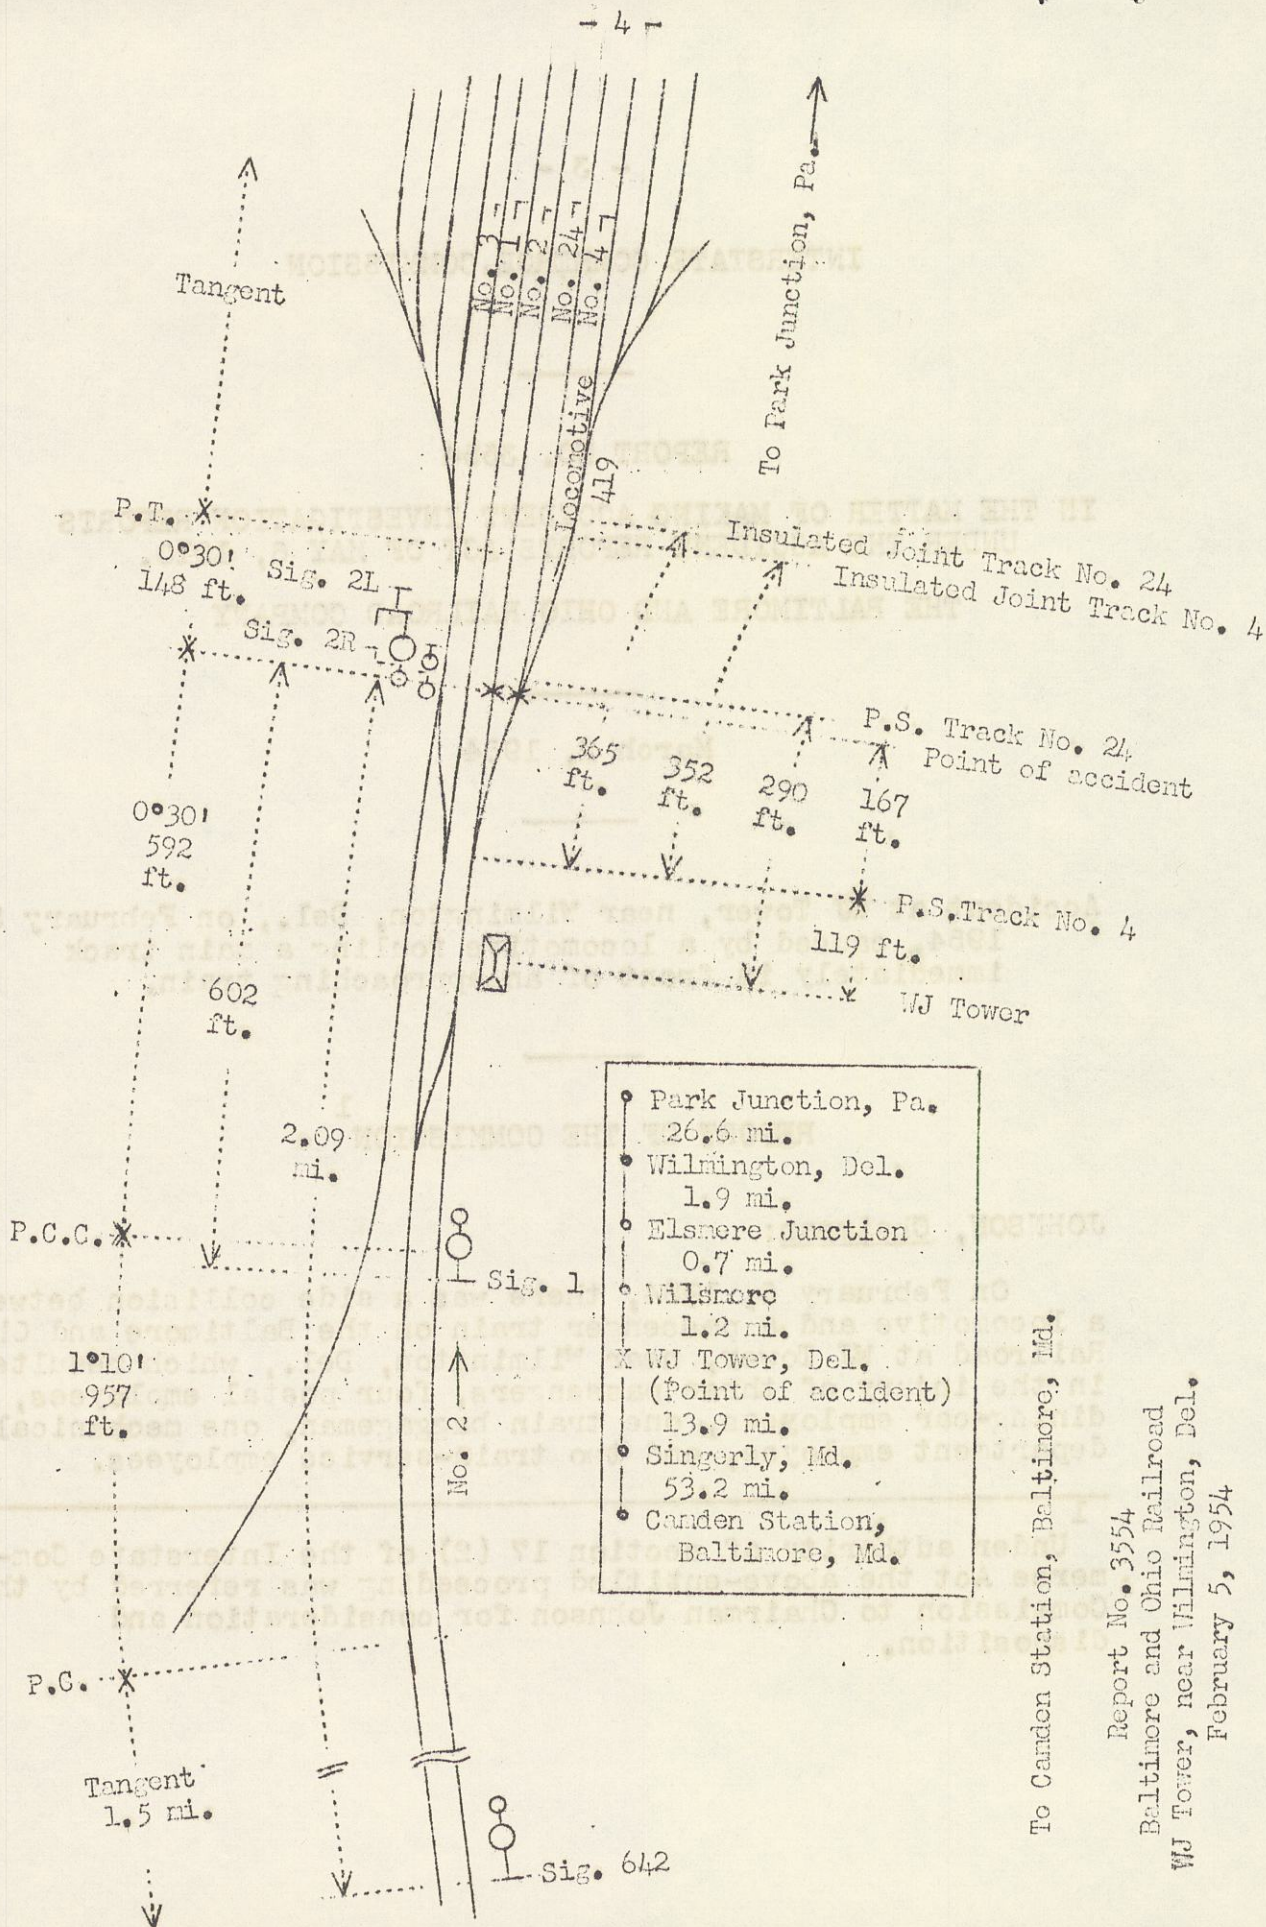
Location of Accident and Method of Operation

This accident occurred on that part of the Baltimore Division extending between Park Junction, Pa., and Camden Station, Baltimore, Md., 97.5 miles. In the vicinity of the point of accident this is a double-track line, over which trains moving with the current of traffic are operated by signal indications supplemented by an intermittent inductive automatic train-stop system. From north to south the main tracks are designated as No. 1, westward, and No. 2, eastward. At Wilsmere, Del., 29.2 miles west of Park Junction, yard tracks parallel track No. 1 on the north and track No. 2 on the south. These yard tracks extend between Elsmere Junction, 0.7 mile east of Wilsmere, and WJ Tower, 1.2 miles west of Wilsmere. At the west end of the yard the track which parallels track No. 1 on the north is designated as track No. 3. The two tracks which parallel track No. 2 on the south are designated from north to south as track No. 24 and track No. 4. Track No. 4 converges with track No. 24 and with track No. 2 at switches located, respectively, 290 feet and 119 feet east of WJ Tower. Immediately west of WJ Tower a trailing-point crossover connects tracks Nos. 1 and 2. Another crossover, which is located opposite the west switch of track No. 4, connects tracks Nos. 1 and 3. This crossover is trailing-point for west-bound movements on track No. 1. The accident occurred west of the fouling point between tracks Nos. 2 and 4, and 167 feet east of the point-of-switch at the west end of track No. 4. From the east on the main tracks there are, in succession, a tangent over 1,000 feet in length, and a  $0^{\circ}30'$  curve to the left 148 feet to the point of accident and 592 feet westward. From the west there are, in succession, a tangent 1.5 miles in length, a  $1^{\circ}10'$  curve to the right 957 feet, and the curve on which the accident occurred. At the point of accident the grade on track No. 4 is 0.05 percent ascending westward, and the grade on track No. 2 is 0.34 percent descending eastward.

Automatic signal 642 and semi-automatic signal 1, governing east-bound movements on track No. 2, are located, respectively, 2.09 miles and 602 feet west of the point of accident. These signals are of the color-position-light type and are approach lighted. Aspects applicable to this investigation and the corresponding indications and names are as follows:

The shunt fouling circuits on tracks Nos. 24 and 4 extend distances of 352 feet and 365 feet, respectively, east of the main-track switch. The joint bars at the insulated joints at the ends of these circuits are painted white.

Locomotive 419 was assigned to yard service at Willsmere. It departed from a point on track No. 4 approximately 3,775 feet east of WJ Tower, proceeded westward on track No. 4, and stopped with the front end west of the fouling point between tracks Nos. 2 and 4, and 167 feet east of the point-of-switch at the west end of track No. 4. Immediately afterward the end of the front bumper beam on the right side of the locomotive was struck by the end of the pilot beam on the right side of the first Diesel-electric unit of No. 2.

of the track, the view of signal 1 from an approaching east-bound locomotive is restricted to a distance of 820 feet. When No. 2 reached a point from which the enginemen could obtain a view of this signal, they observed that the signal indicated Proceed. When locomotive 419 entered the shunt fouling circuit at the west end of track No. 4, the indication of signal 1 changed from Proceed to Stop. The engineer of No. 2 saw the indication of the signal change, and he said he thought that at this time his locomotive was about 600 feet west of the signal. He immediately made an emergency application of the brakes. According to the tape of the speed recording device, the speed was 79 miles per hour when the brake application became effective and had been reduced to 75 miles per hour when the collision occurred.

The painted joint bars near the end of track No. 4 mark the insulated joints at the end of the shunt fouling circuit. There is nothing provided to indicate the actual clearance point. In the instant case the engineer of locomotive 419 said that he intended to stop short of the painted joint bars and that when he failed to see them he overran the fouling point between tracks Nos. 2 and 4. The carrier should give consideration to providing means of more clearly indicating the locations of clearance points at switches where other protection is not provided.
